AFRL Solid Propellant Laboratory Explosive Siting and Renovation Lessons Learned

Daniel F. Schwartz
Air Force Research Laboratory Propulsion Directorate,
10 E. Saturn Blvd. Edwards AFB, CA 93524-7380
Phone: (661) 275-5791
Fax: (661) 275-5435
daniel.schwartz@edwards.af.mil

13. SUPPLEMENTARY NOTES See also ADM002313. Department of Defense Explosives Safety Board Seminar (34th) held in Portland, Oregon on 13-15 July 2010, The original document contains color images.

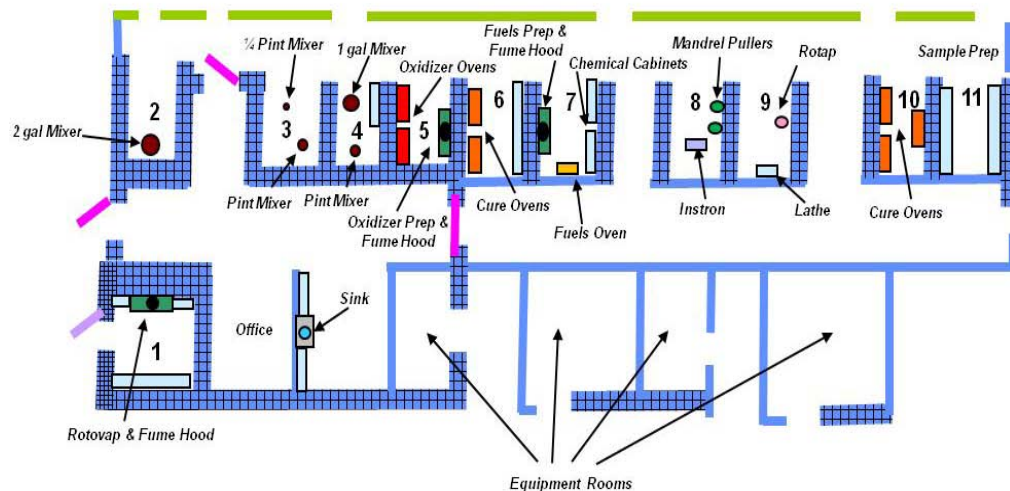
Figure 1. Bldg 8473 Pre-Renovation Layout

Before the renovation, Bldg 8473 consisted of eleven reinforced concrete cells with blow-out rear walls, explosion resistant windows and remote manipulators (Cells: 1-4, 8, 9 and 11). The basic operations consisted of: mixing, casting and curing of high energy solid propellants. Remote operations were performed behind blast walls in the hallways while looking through explosion resistant glass windows. The basic layout is shown in Figure 1.

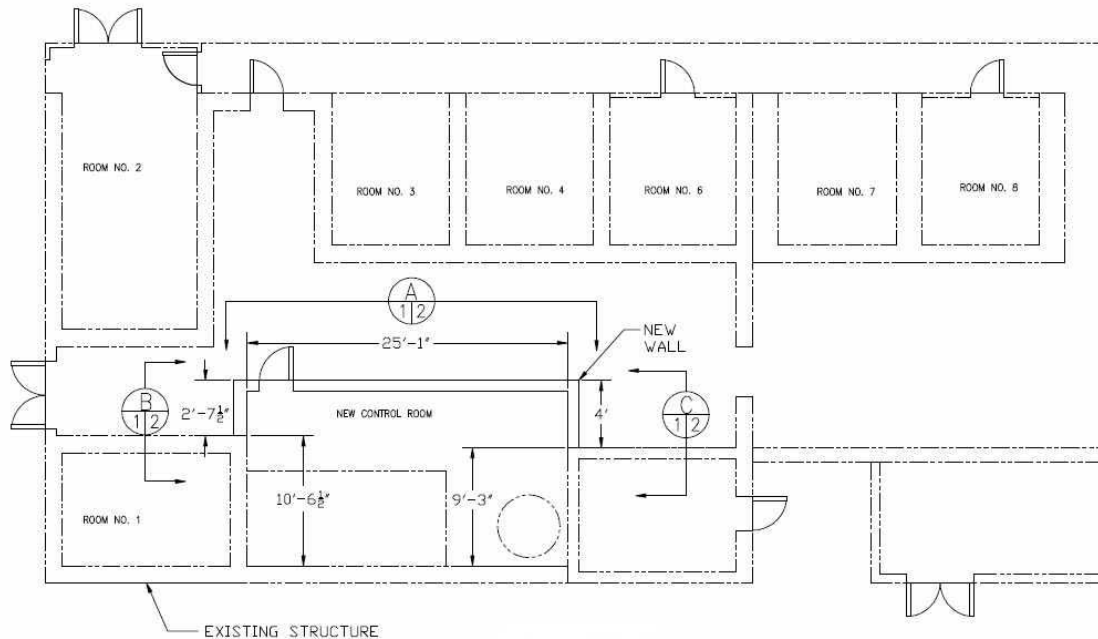
Figure 1. Proposed layout of the new hardened control room

The NAVFAC ESC engineering analysis determined that all of the issues AES identified for Cells 1-11 would be mitigated by requiring personnel to conduct remote operations from inside the hardened control room with the blast door closed and all other building occupants to maintain minimum standoff distance from explosive operations.

The scope of the NAVFAC ESC contract was expanded to include a preliminary design of a hardened control room to protect personnel from blast and fragment hazards. The NAVFAC ESC design was for an 8-inch reinforced concrete wall composed of 4 ksi concrete with #4 bars spaced at 12 inches on center each way for each face, anchored into the existing reinforced concrete walls and a 3 psi rated blast door. The general layout of the control room proposed by NAVFAC ESC is shown in Figure 1. AES was tasked to provide a detailed design with inputs from NAVFAC ESC.

The final AES design of the hardened control room and blast door were reviewed and endorsed by NAVFAC ESC “The hardened control room walls and blast door are designed to sufficiently resist any fragments and residual leakage blast pressure generated by an accidental explosion from one of the test cells. The blast door is the DB-200 Model from Protective Door Industries, has a minimum ultimate unit resistance of 3 psi and large ductility capabilities to attain large deflections, would be loaded in the seated direction, and has a custom door frame and anchors designed specifically to resist the blast loads and develop the full resistance of the door.”
